Appendix A: Photographs

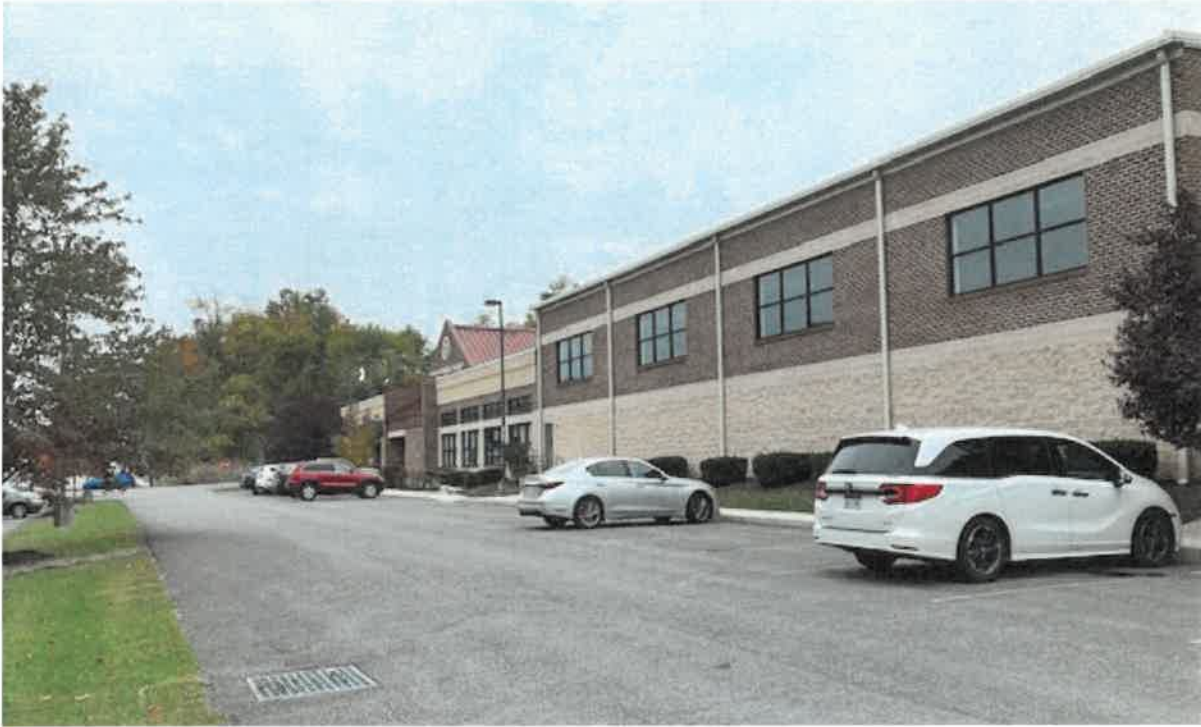
Building Overview Looking Northeast

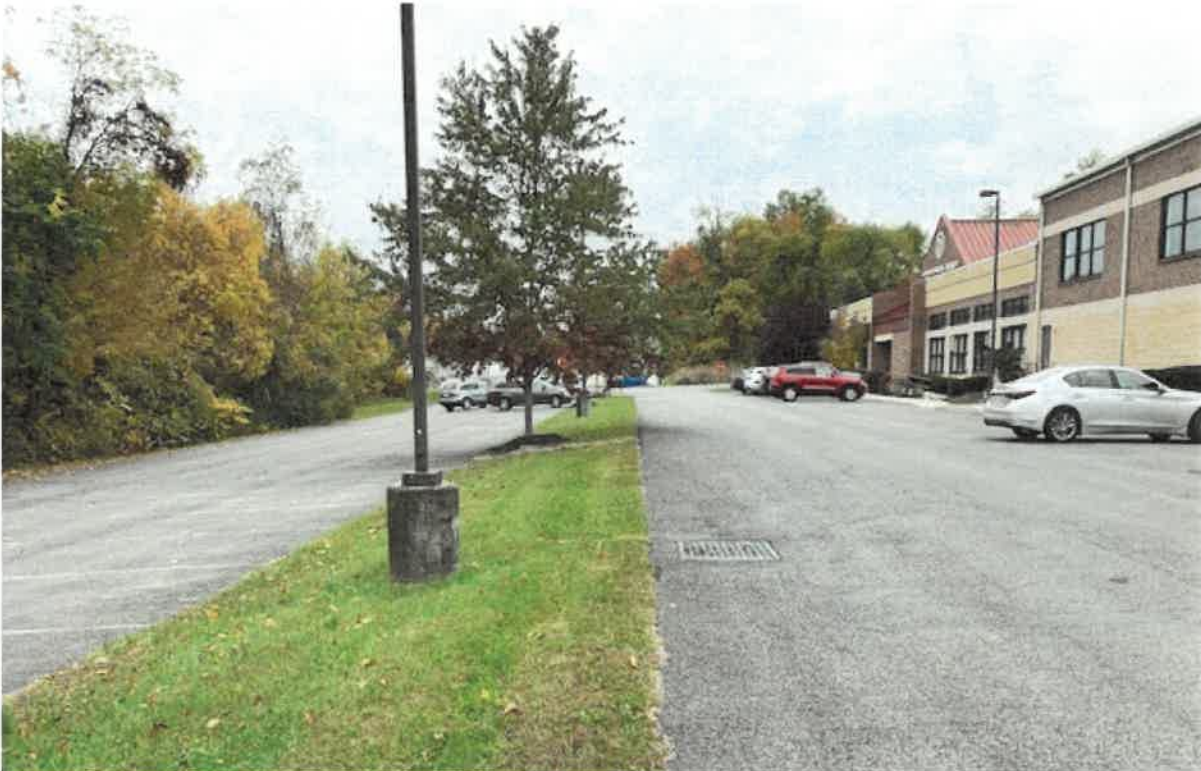
Property Overview Looking East toward Fitness Lane.

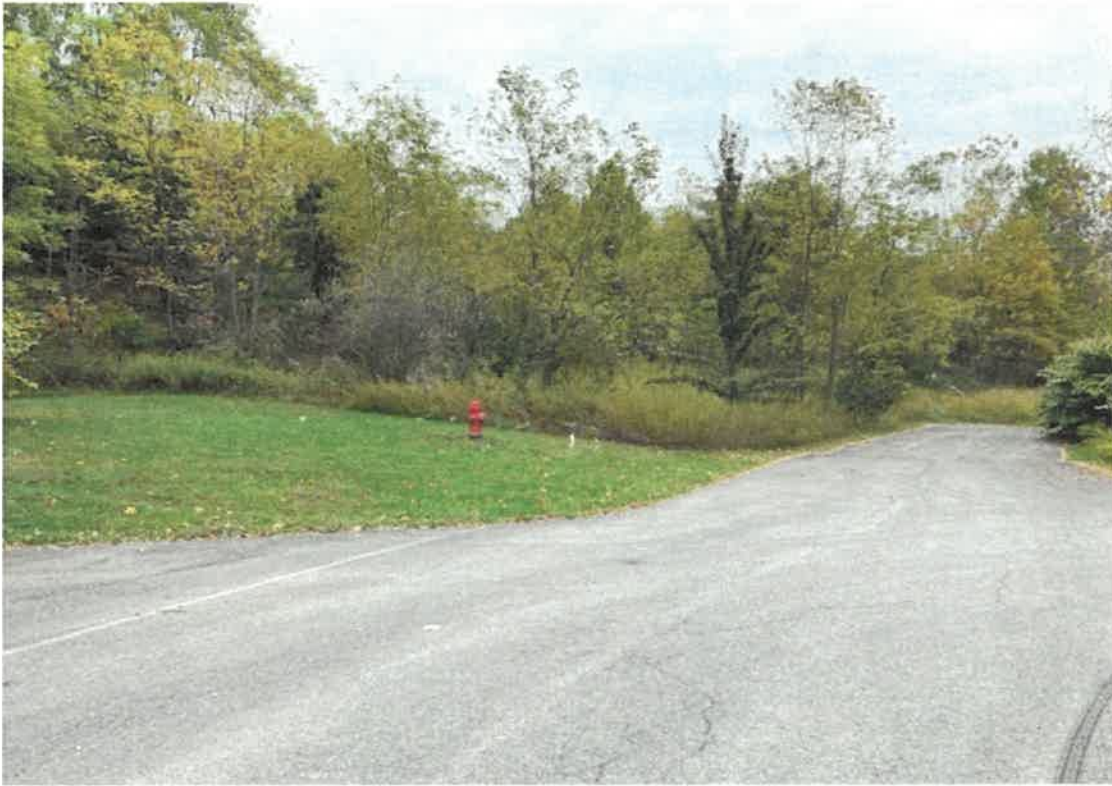
Existing end of driveway and fire hydrant at west end of structure.

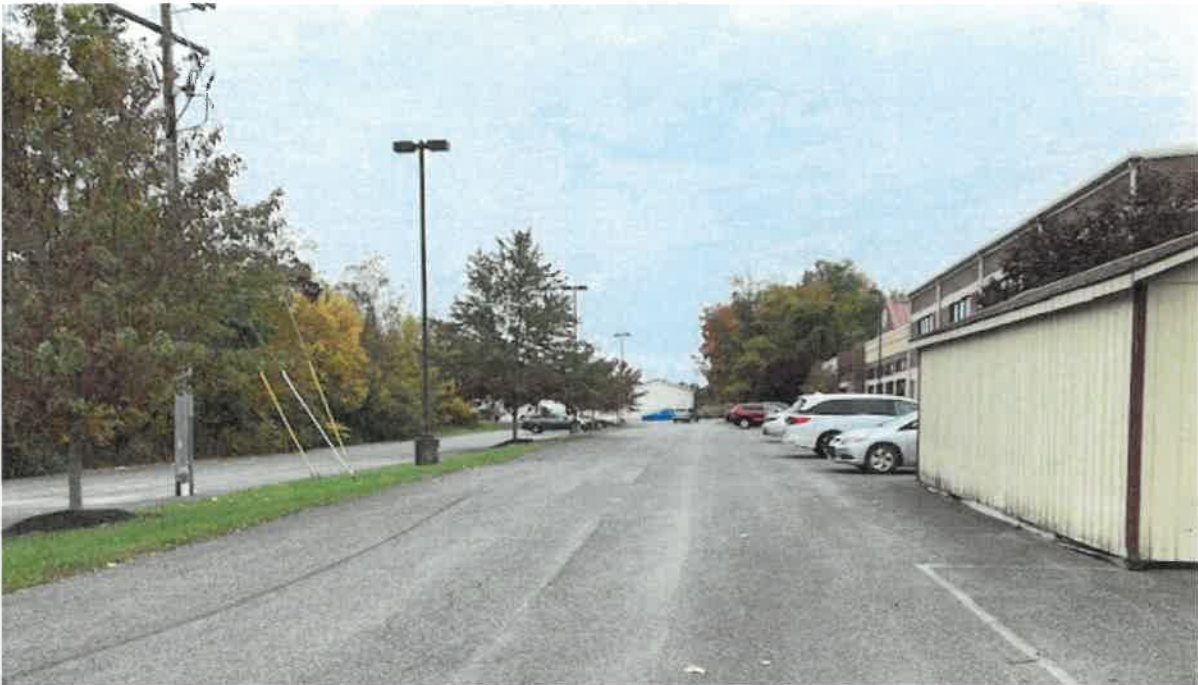
Fitness Lane looking West to East.

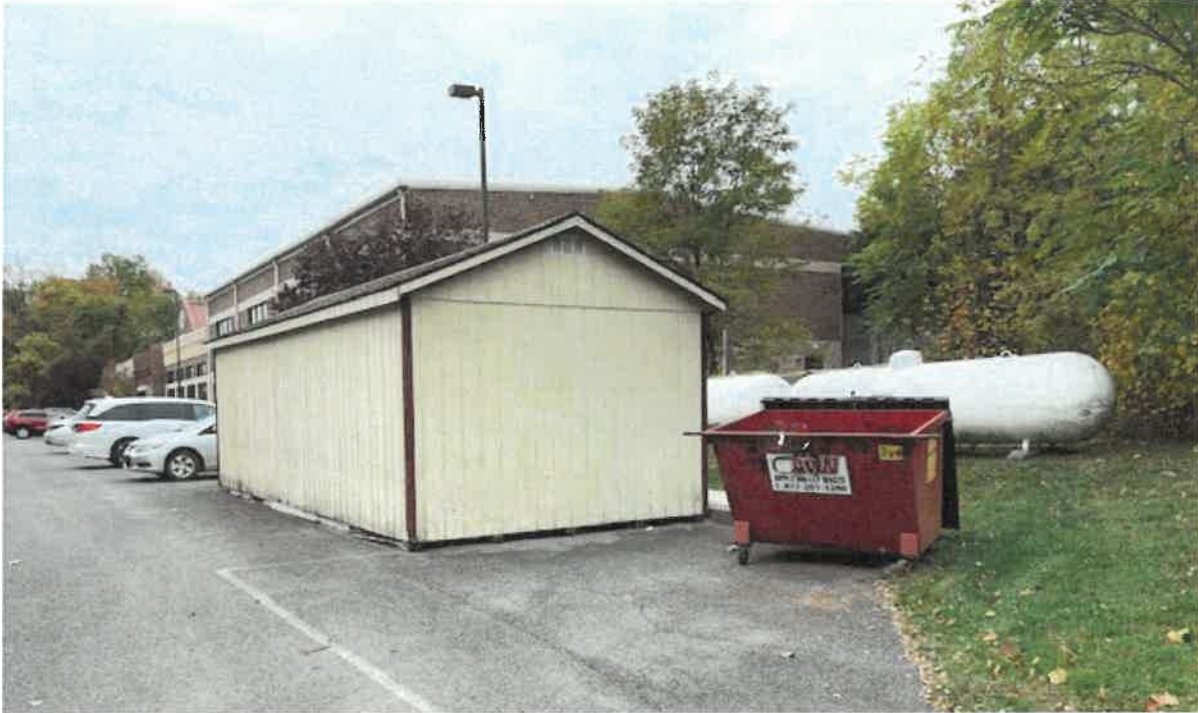
Existing Shed located on West side of structure.

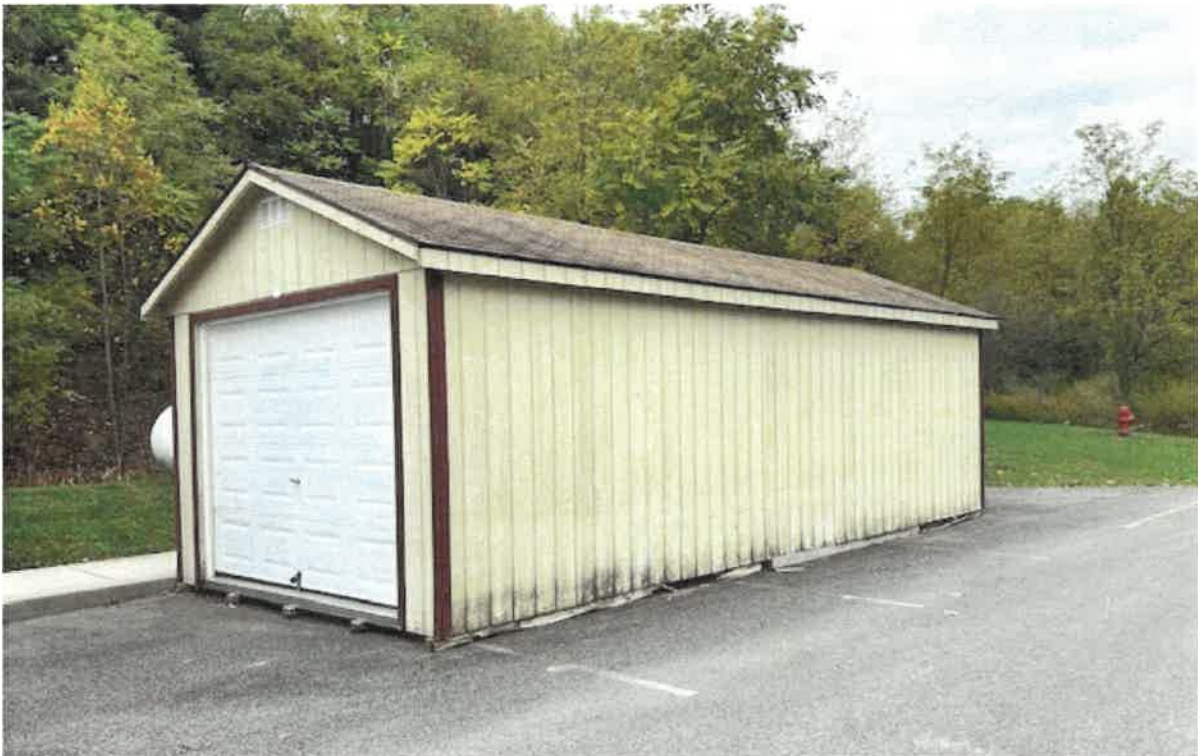
Existing shed positioned in parking lot.

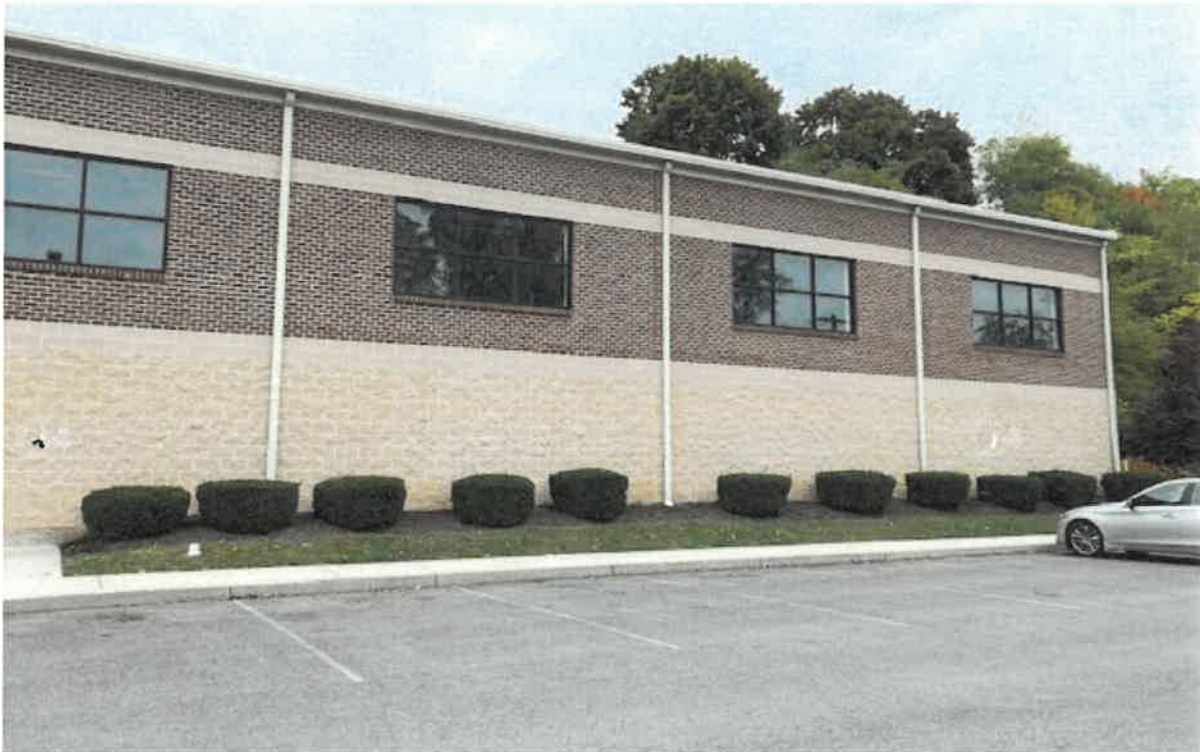
Looking Northwest from Main Entrance.

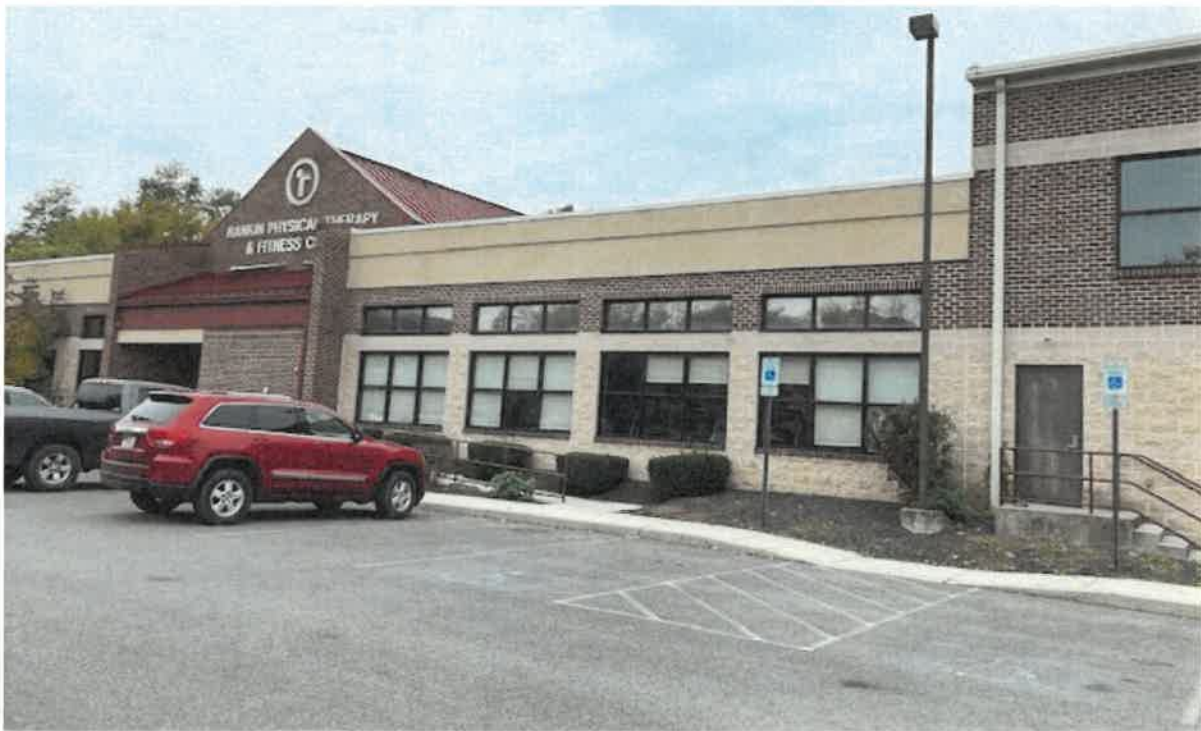
Main Entrance with designated handicap parking and access ramp into facility.

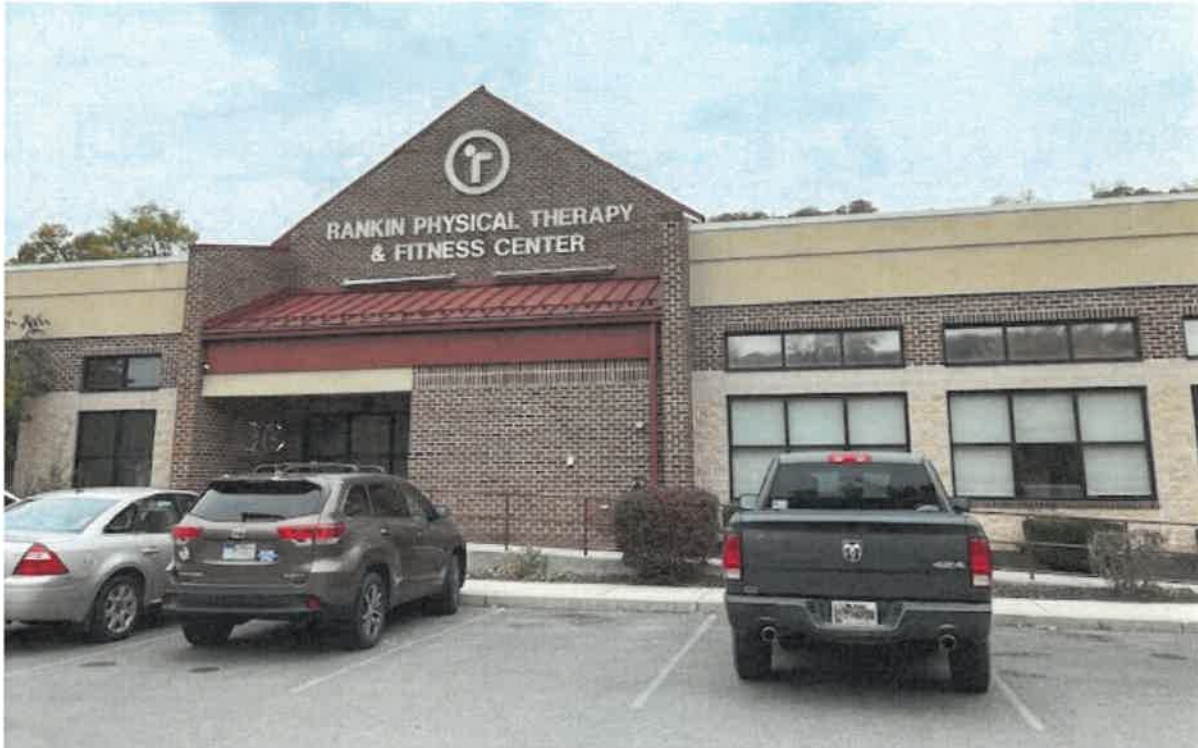
Main Entrance looking North.

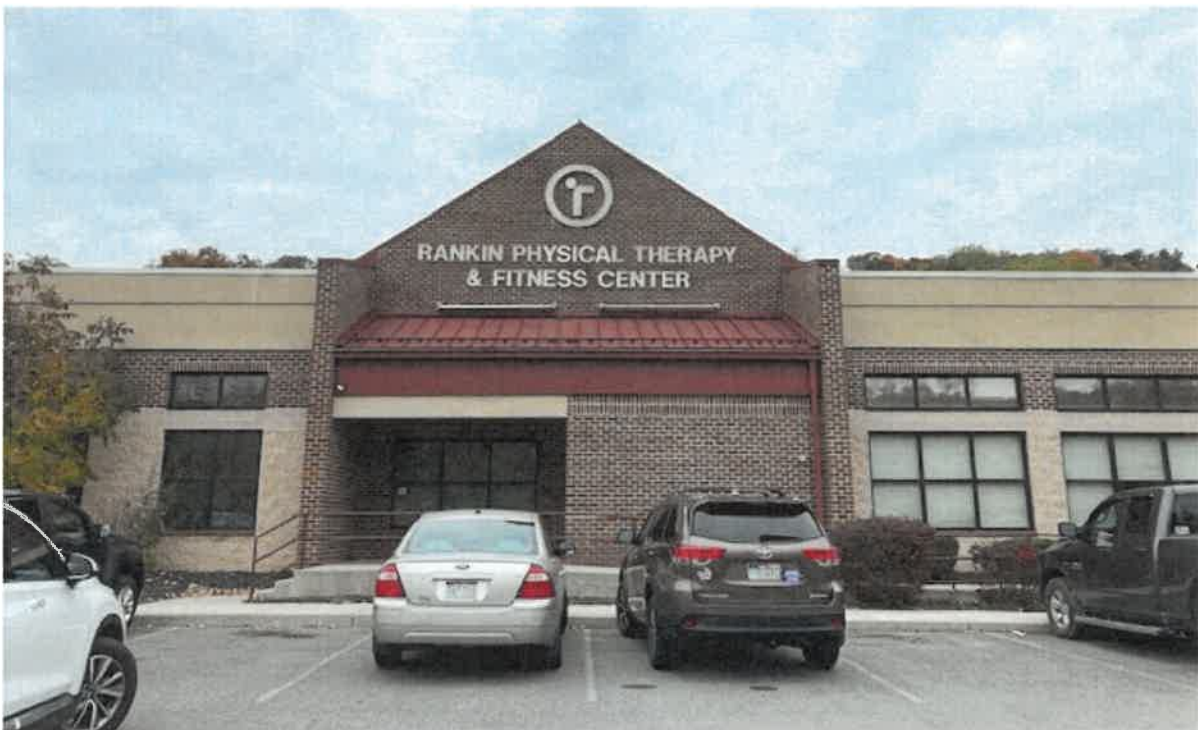
Main Entrance.

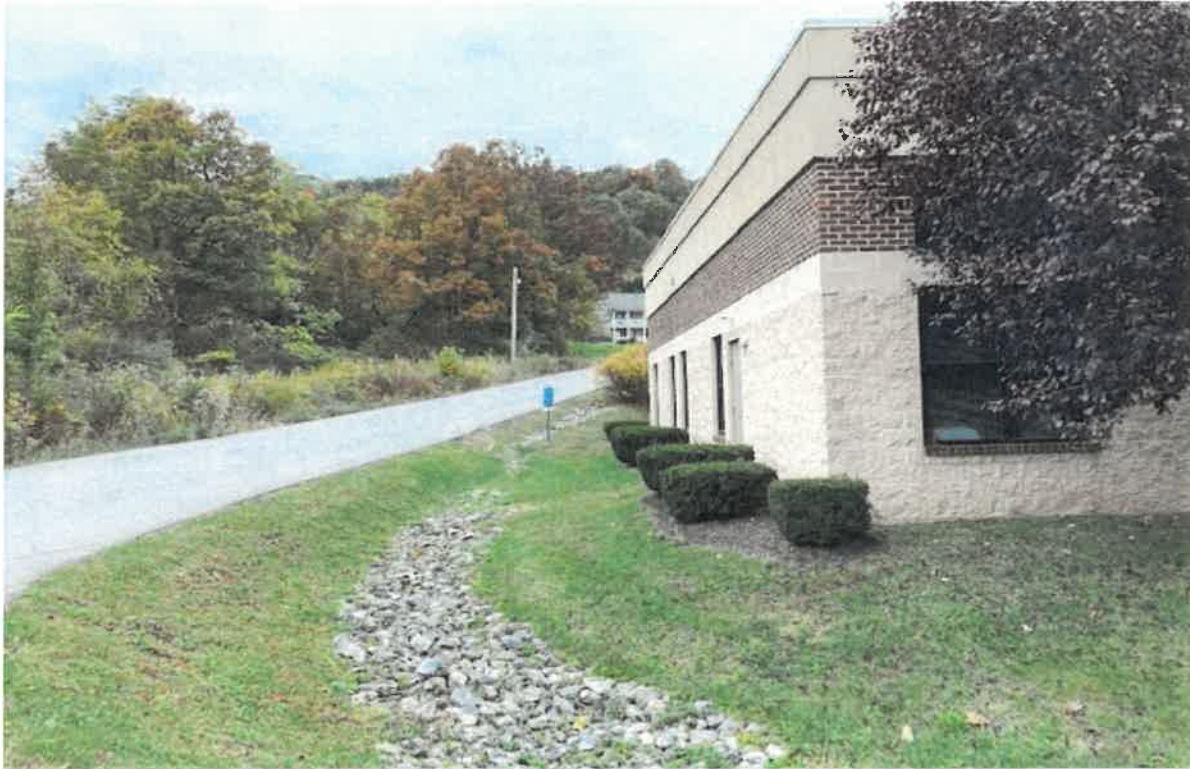
Lower End of Site on Northeast corner.

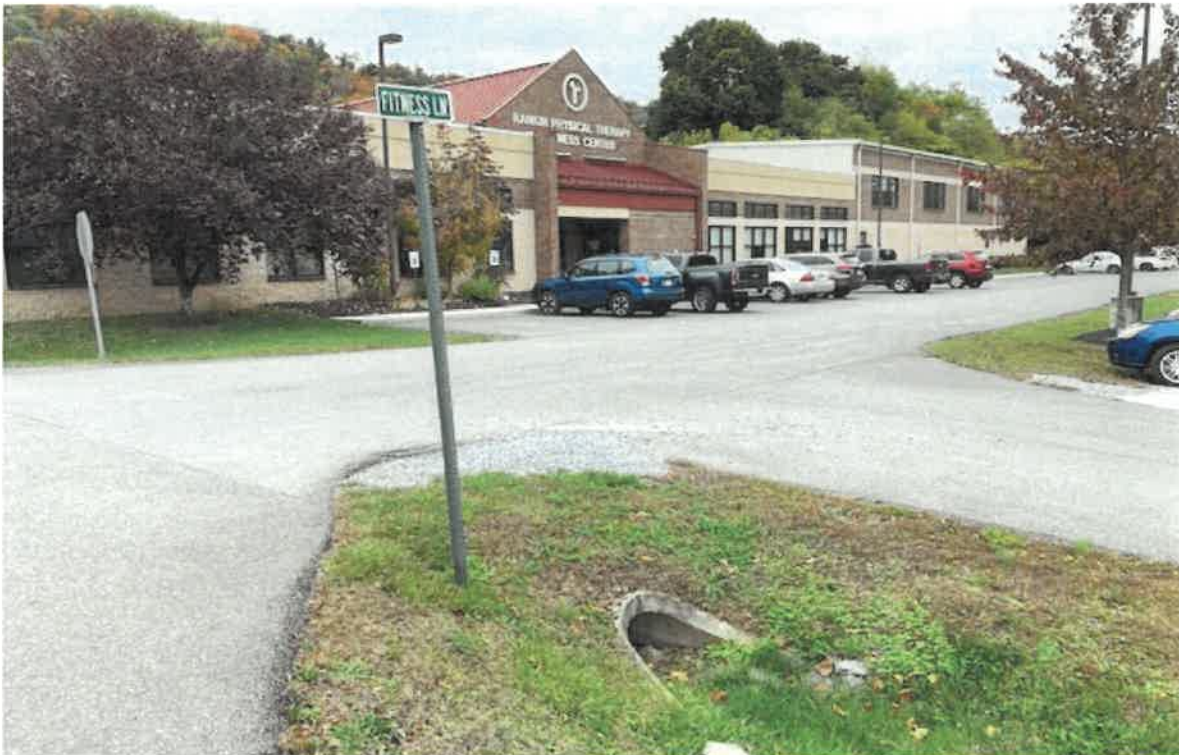
Existing driveway, Fitness Lane, along Front Entrance at North side.

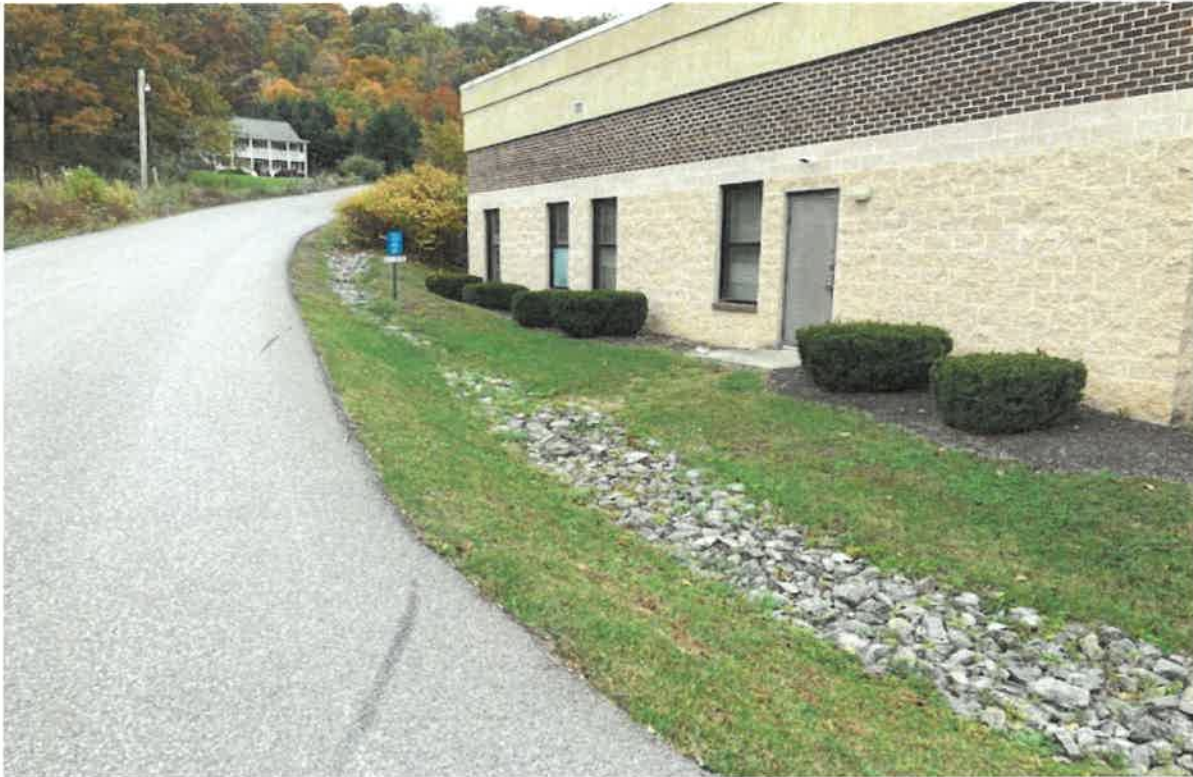
Lower End of Site on East side.

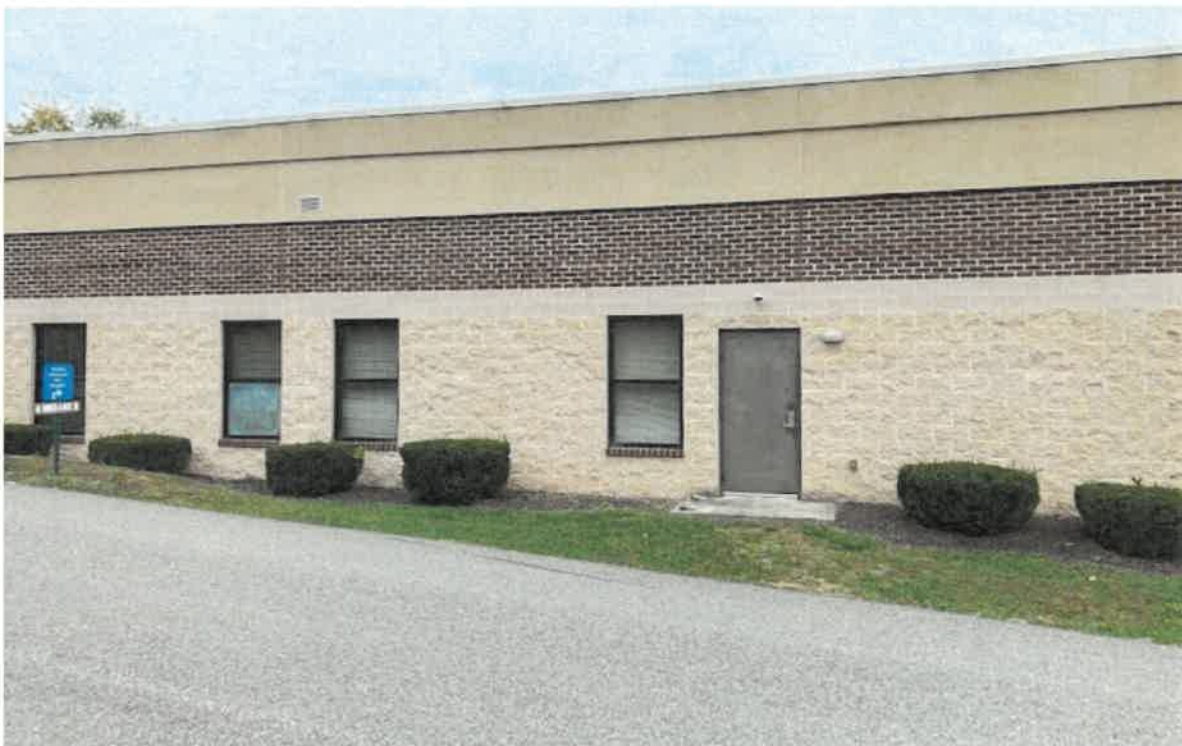
Looking at East side

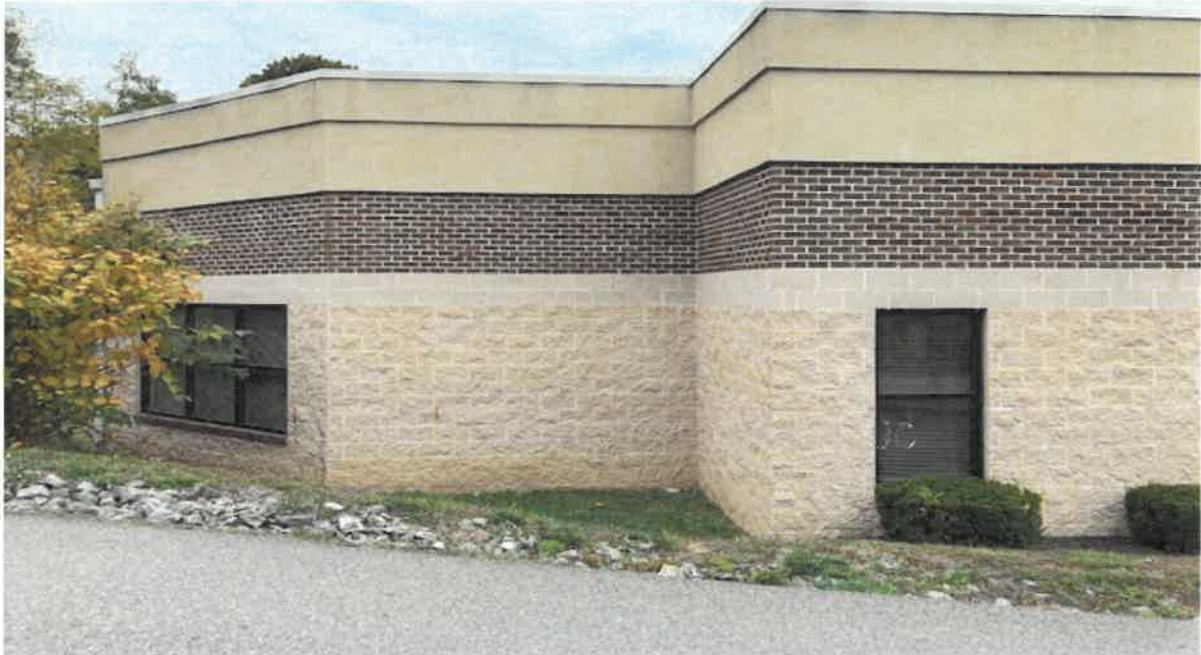
Lower End of Site looking toward Southeast corner

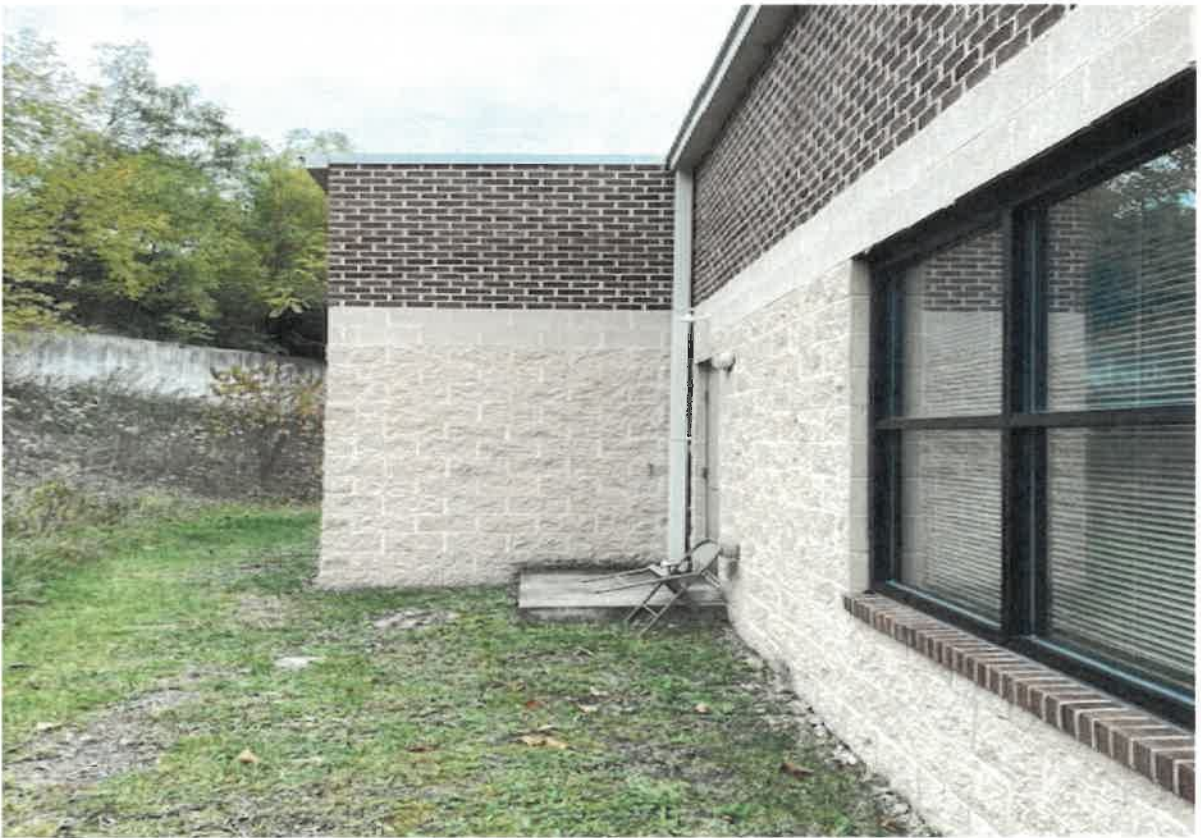
Backside of property facing South

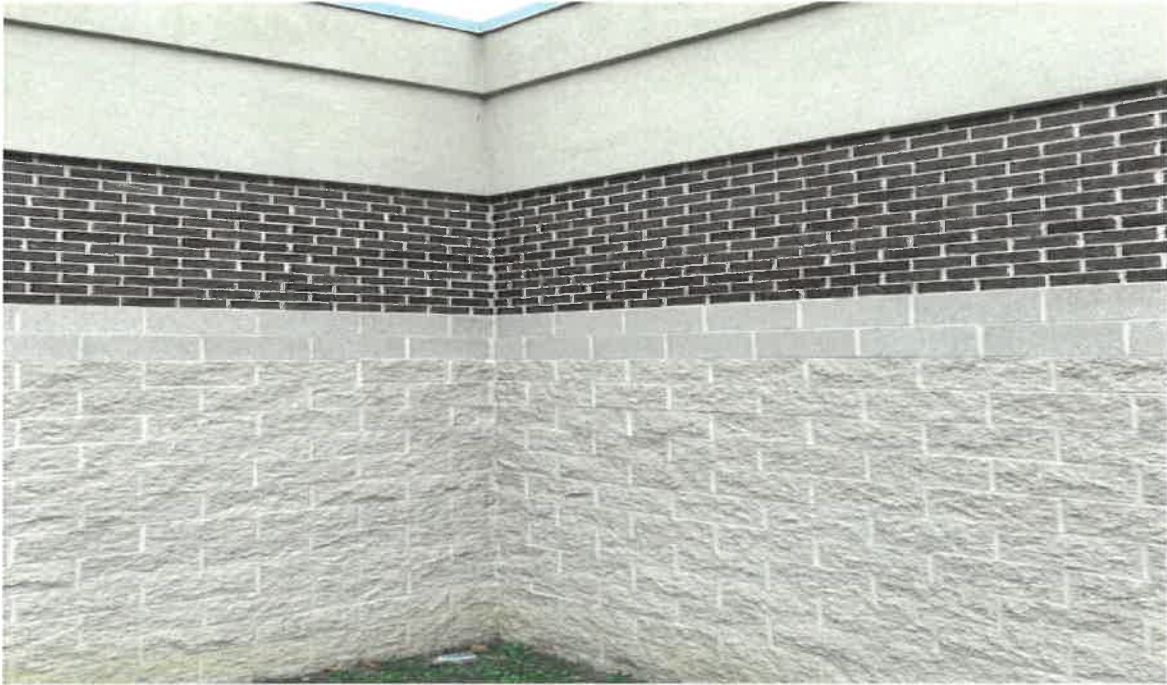
Looking at Southeast corner of building

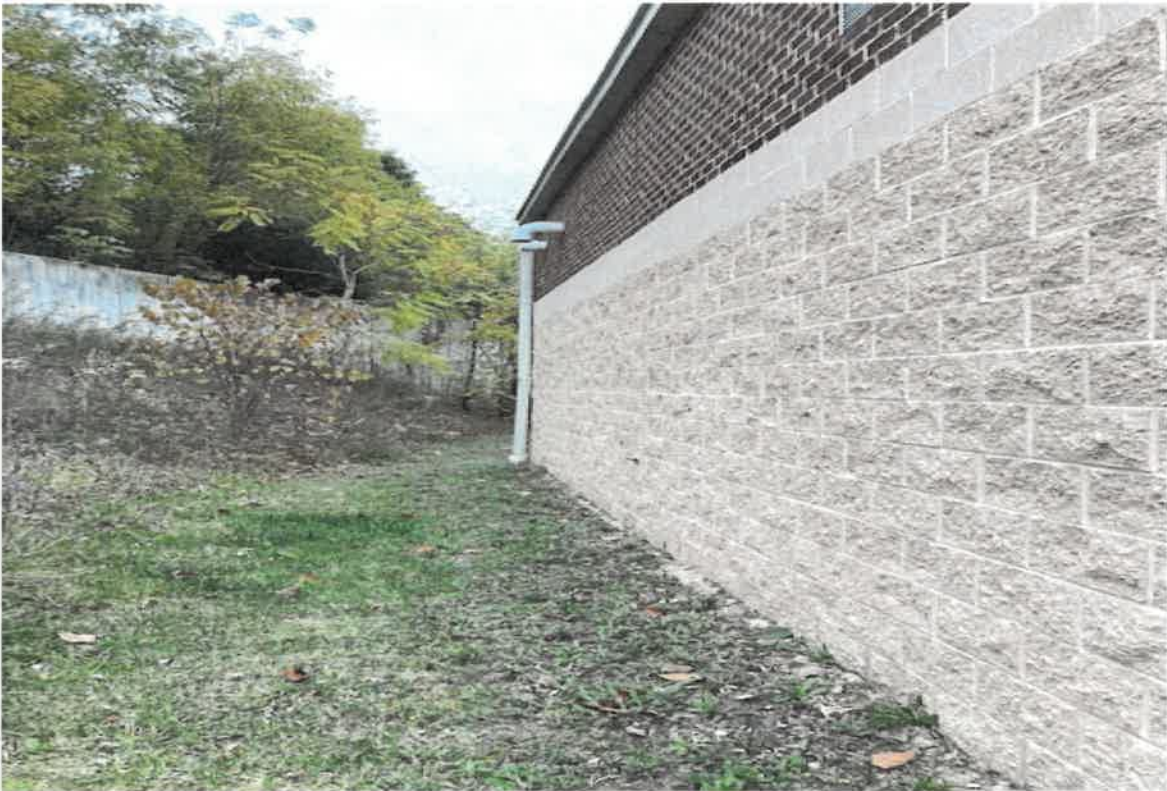
Looking Southwest at grade and retaining wall.

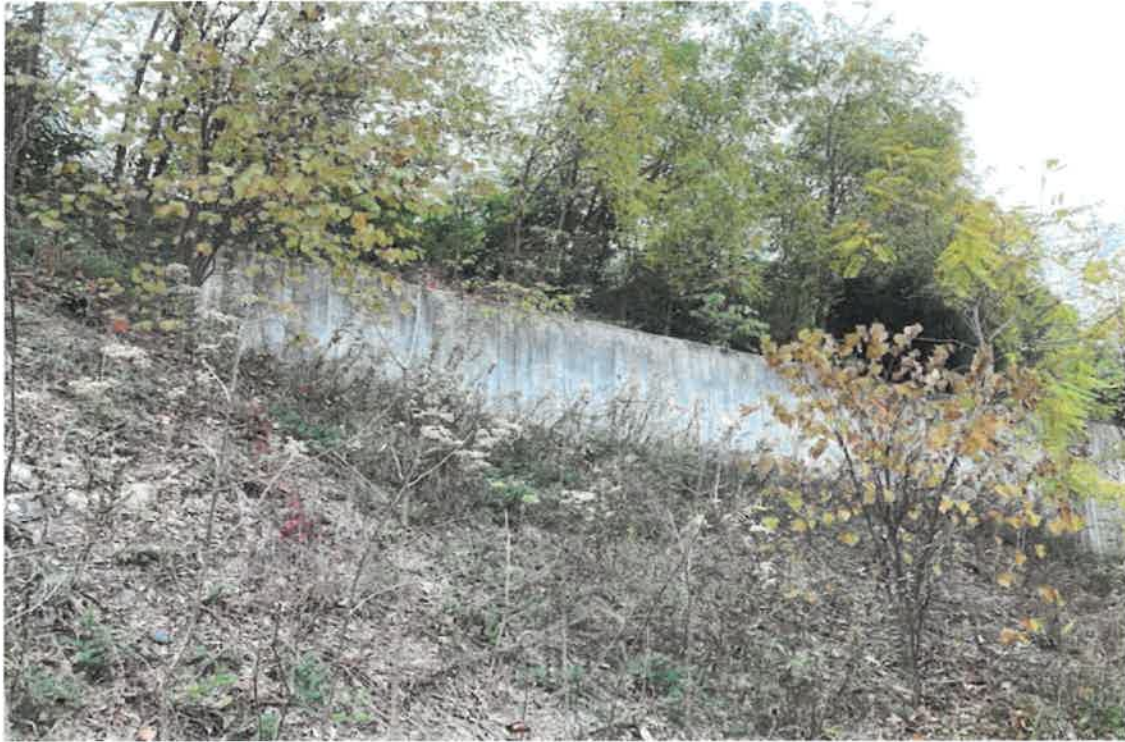
South side of property looking at slope and retaining wall.

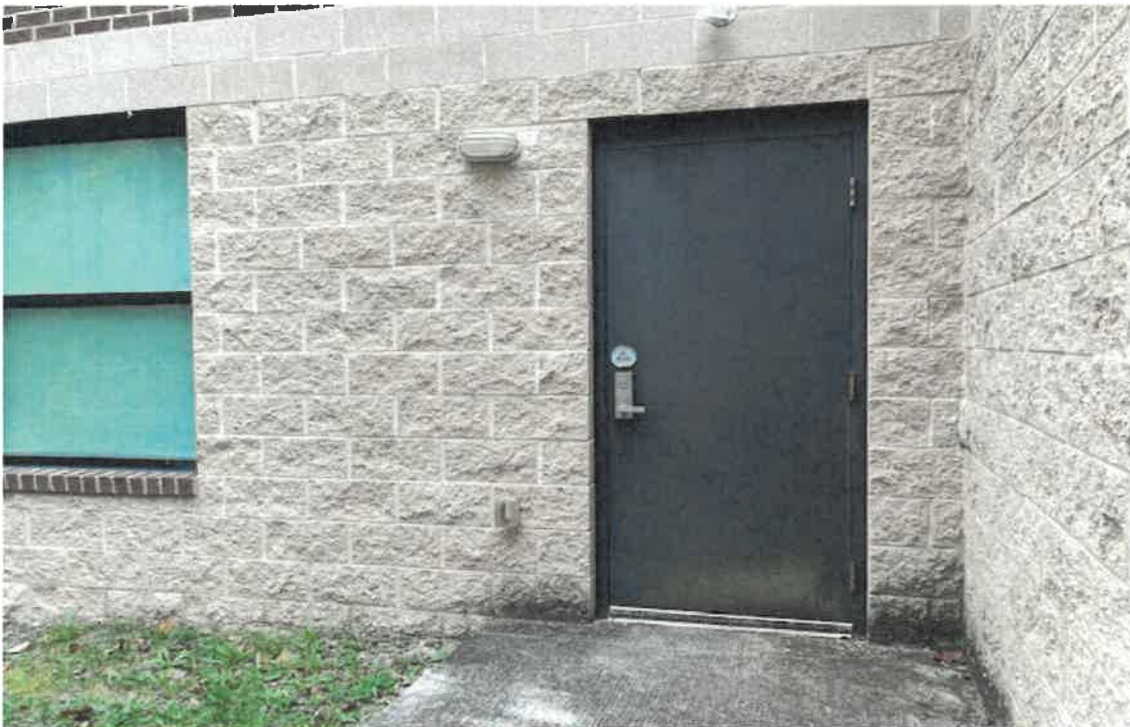
South side of building, secured rear entrance.

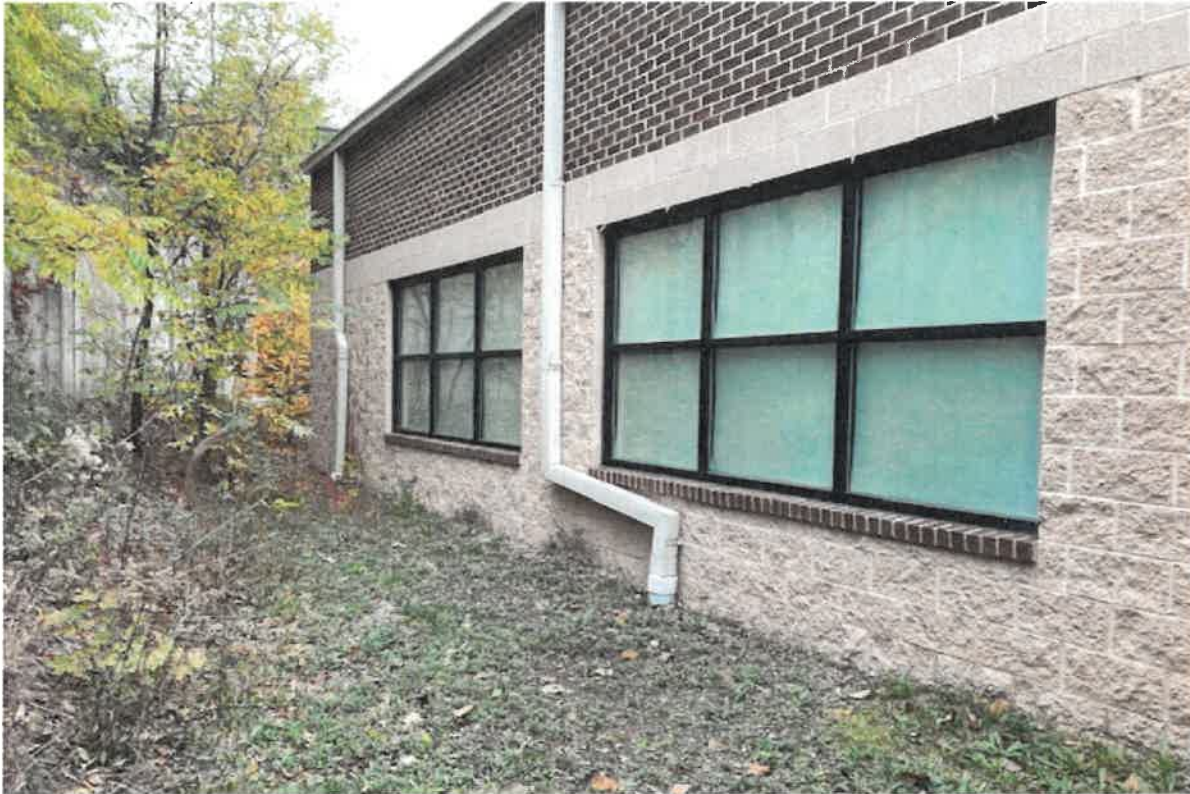
Looking at south side of building showing gutters and downspout.

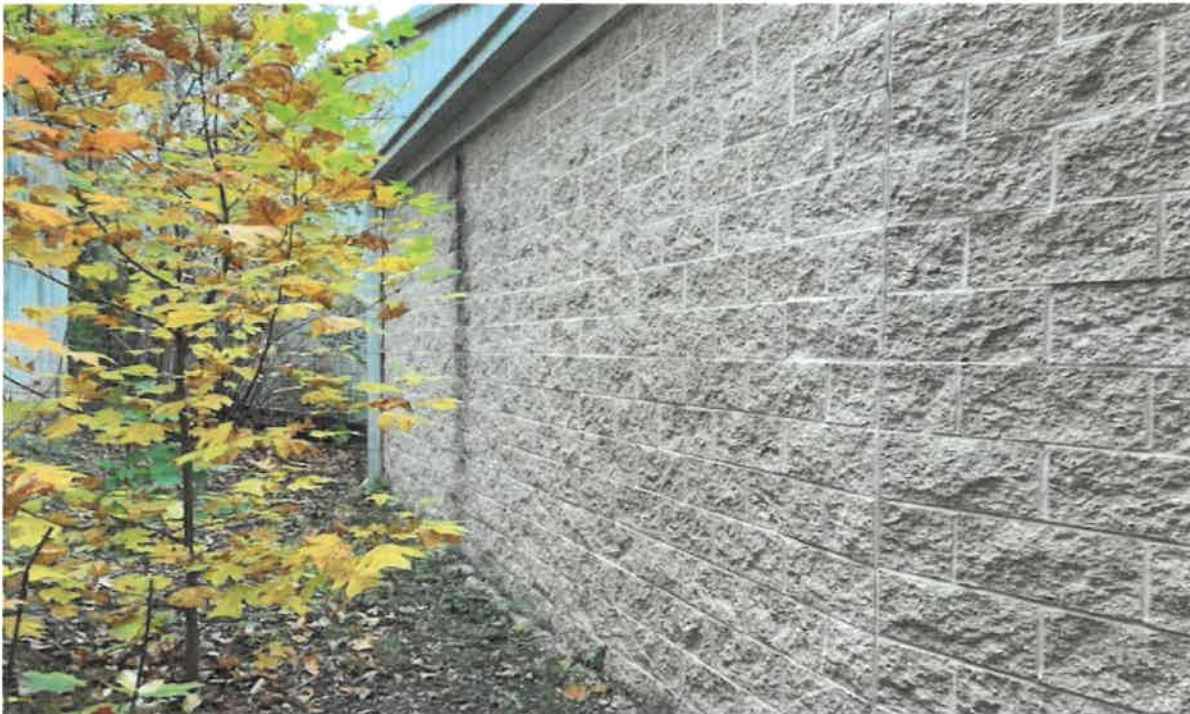
Looking at south side of building showing gutters and down spout.

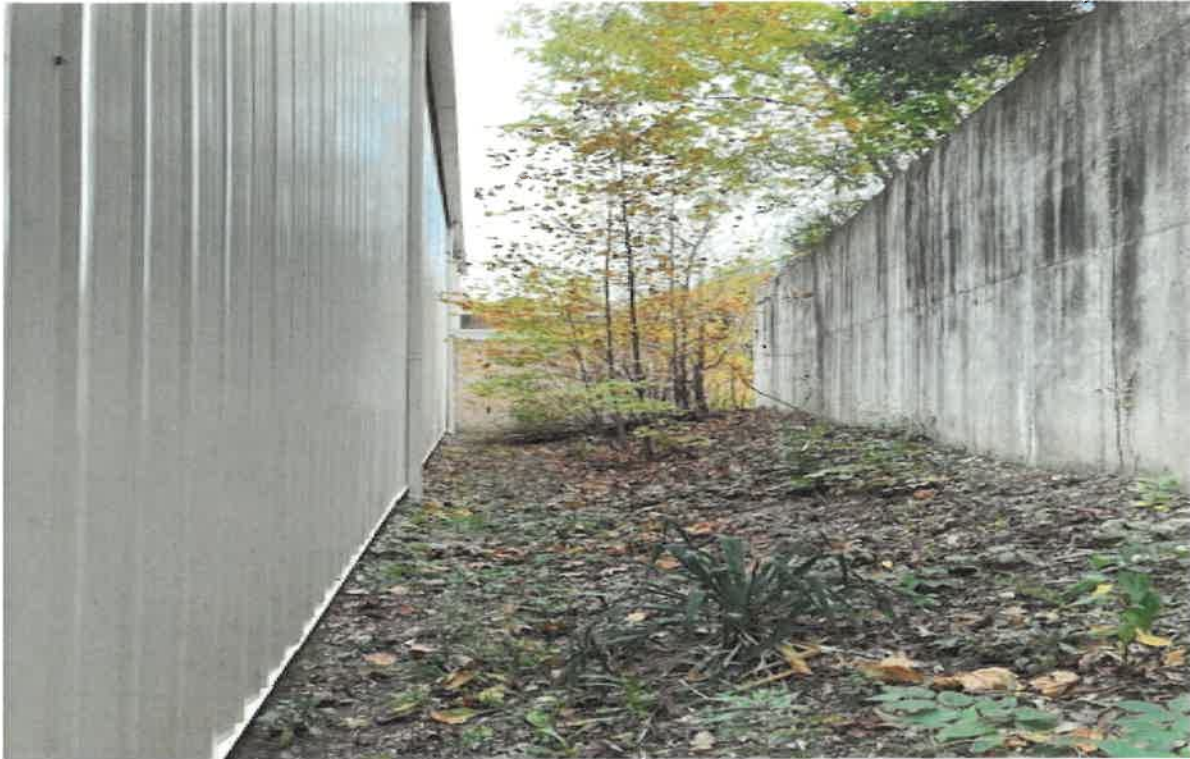
South side of property, the retaining wall with weep holes in place, along the entire span.

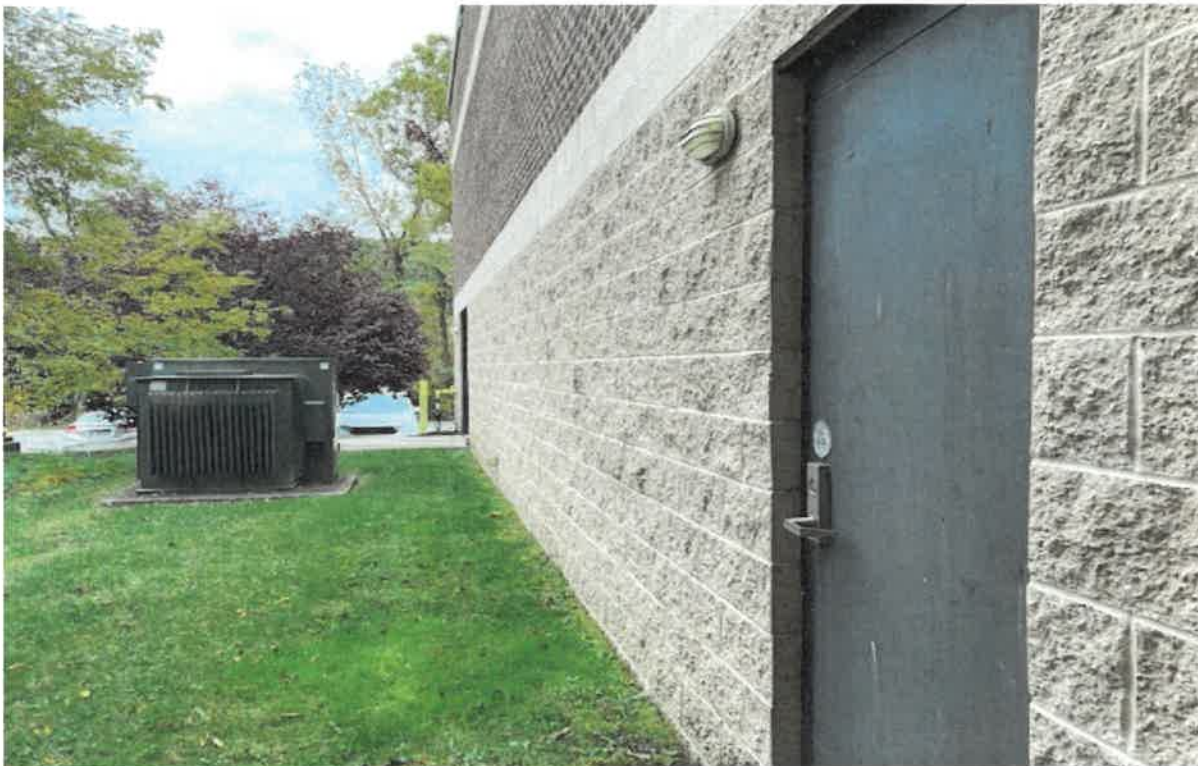
Upper End of Facility looking North

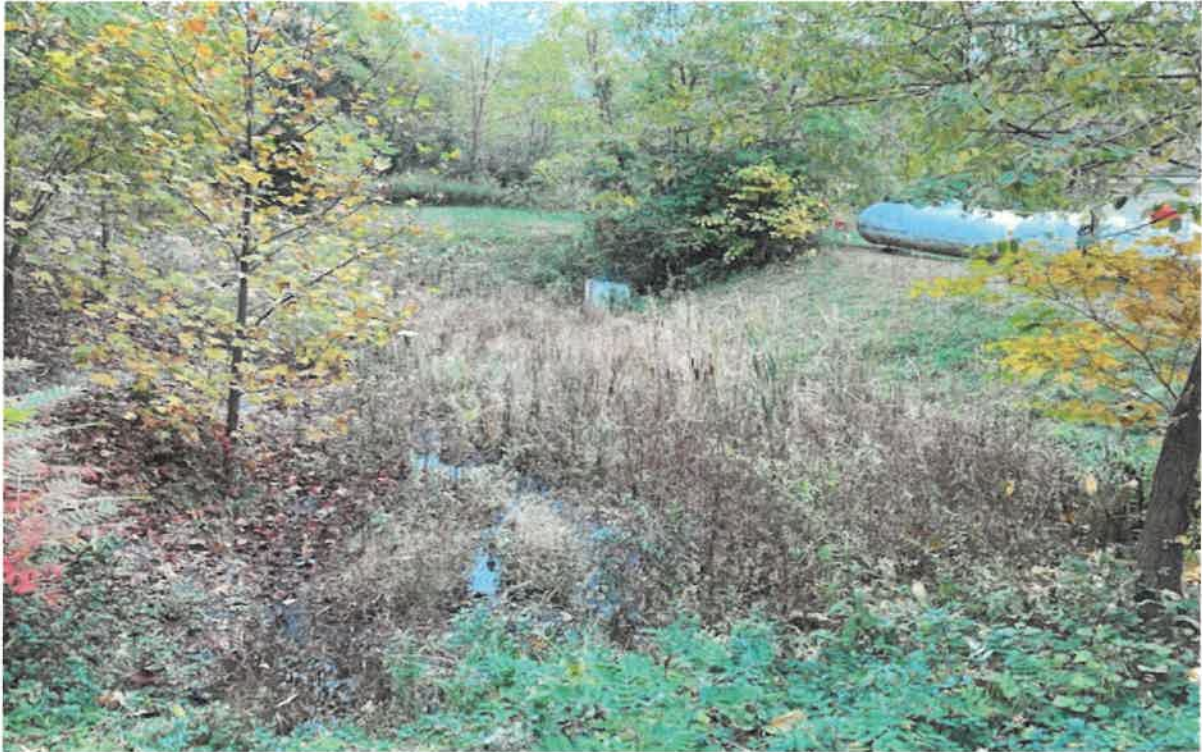
Upper End of Site looking North

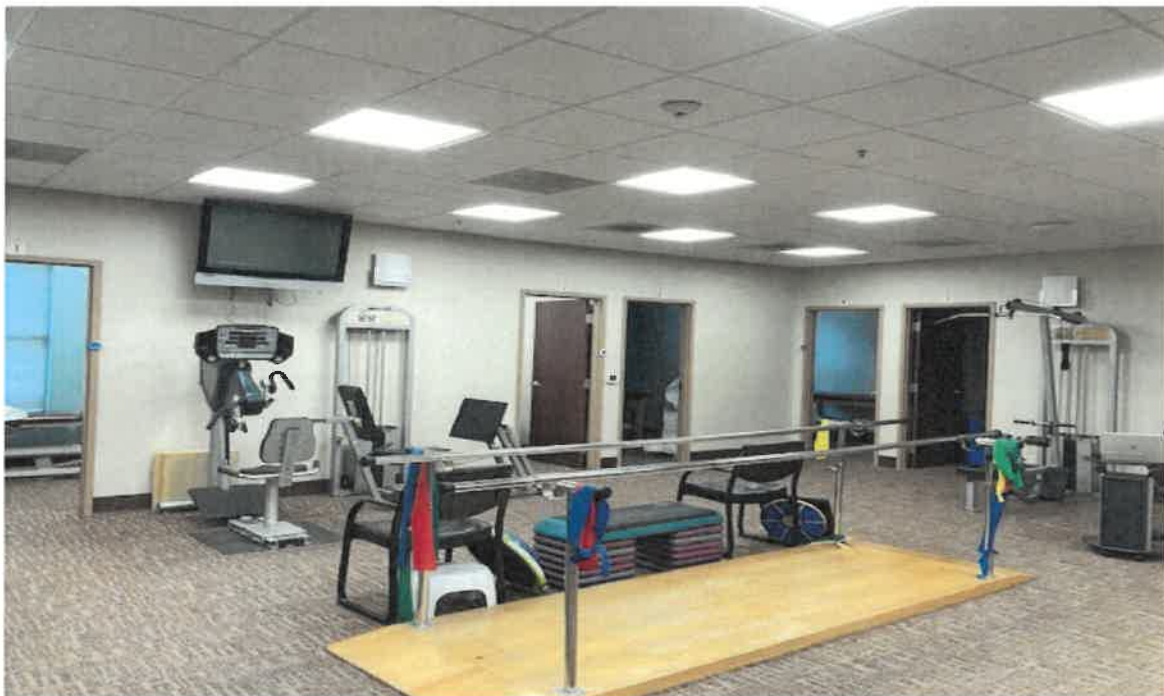
Private Physical Therapy Room
